Community, Development and Heritage Committee Meeting Agenda

4.1 1921 Avenue of Sugar Gums, Hazelwood Park

TREE EVALUATION / ASSESSMENT

- Aerial inspection of the avenue of Sugar Gums (*Eucalyptus cladocalyx*) located along the main driveway into Hazelwood Park Reserve.

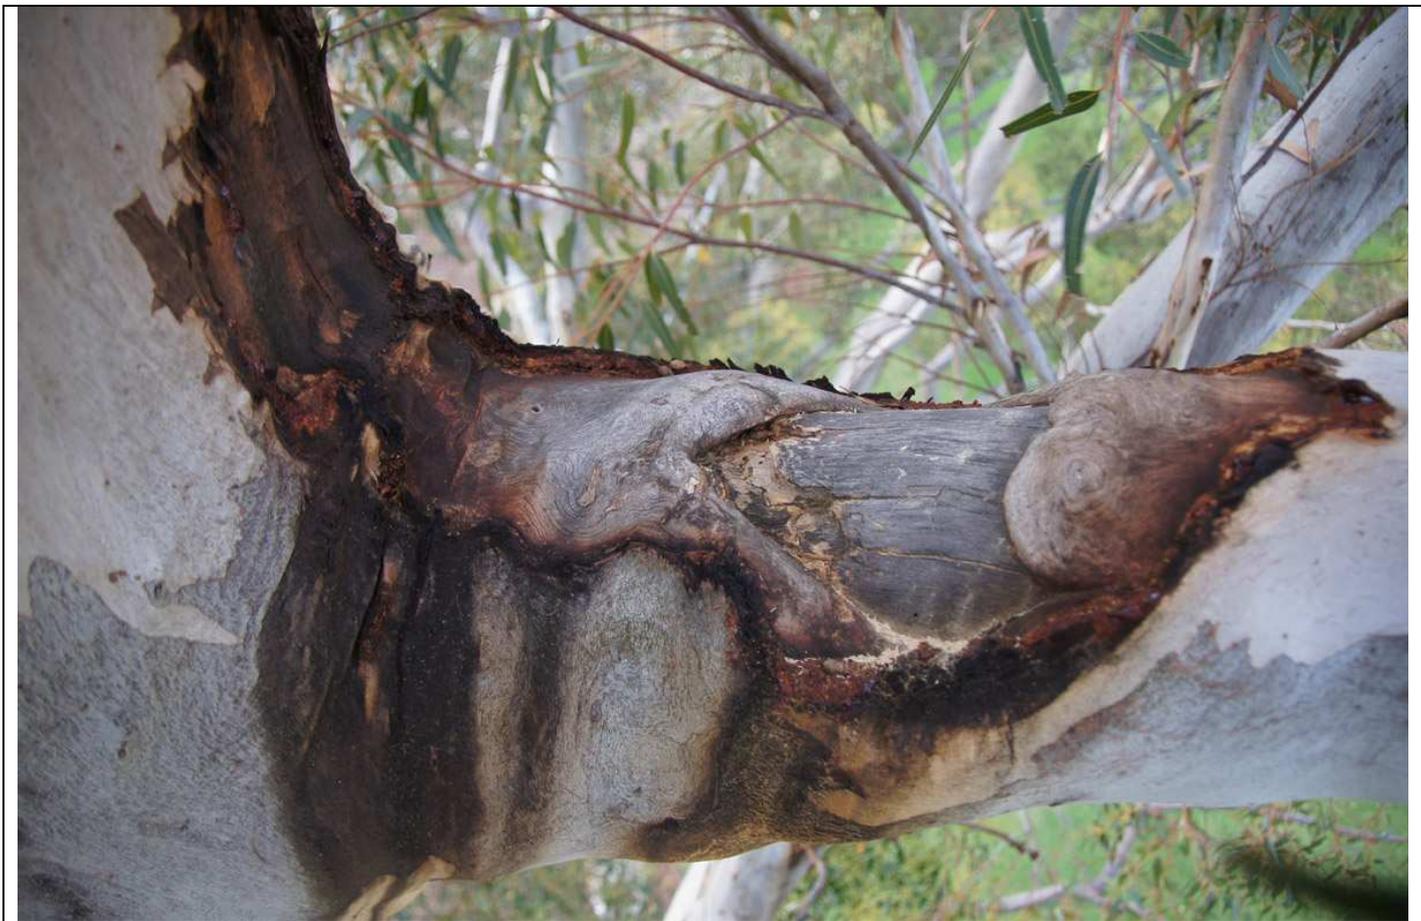
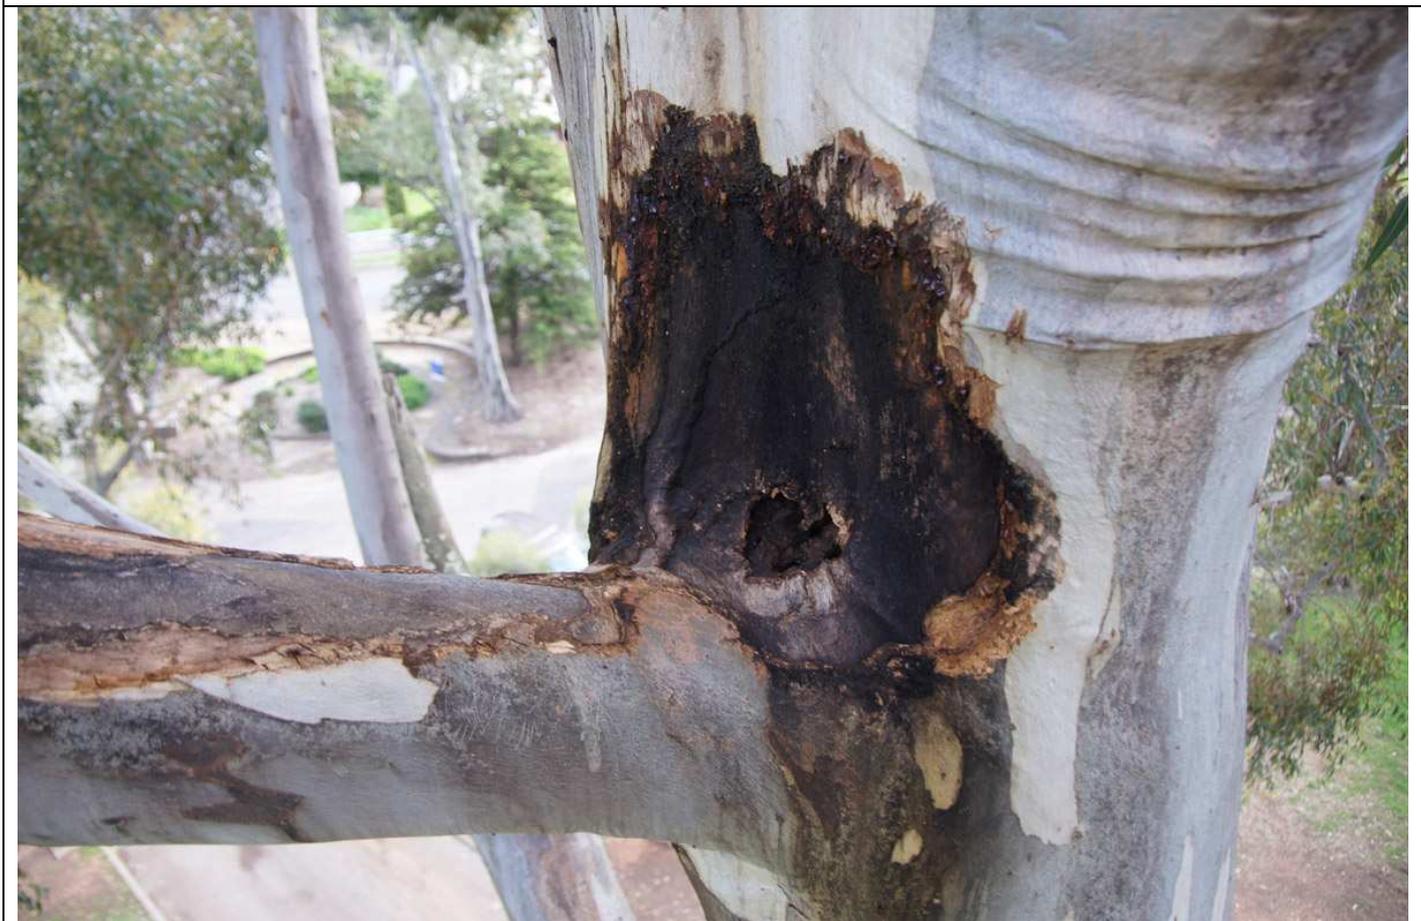
- 1.8. The aerial inspection of the trees on the western side of the avenue identified major damage in the upper canopy unions from bird predation. This has resulted in the removal of a large amount of bark and branch tissue forming the upper surface of the branch unions.

- 1.9. This will have reduced the trees capacity to respond to the damage by removing live tissue and the main growth point of the branch. The loss of cambial tissue will ultimately reduce the implementation of reaction wood formation that hardwood trees rely on to offer support at branch connection points.

- 1.10. This will ultimately result in a weakening of the union whilst further weight loading will continue as the branch implements further extension growth and foliage production, increasing the potential for future branch failures.

- 1.11. To further compound the bird damage numerous wounds on the western most trees were showing signs of hollowing at the unions from normal wood degradation, which will further weaken the branch connection points.

- 1.13. A large number of the unions exhibiting decay were found to have localised hollowing that extended up the branch and into the main stem tissue. However, the surrounding tissue and woundwood formation on the most part was found to be of a reasonable quality.

- 1.14. The main issue with regard to woundwood formation is the continued predation by birds of the newly formed tissue, thus preventing the establishment of new strengthening tissue and occlusion.

Photographs demonstrating the typical, extensive damage on the upper surface of the scaffold branch unions in the upper canopy.

- 1.16. From a risk perspective the trees located on the western side of the avenue will require extensive canopy management to address issues surrounding structural defects within the upper canopy structure.

- 1.20. The formation of a tree management plan for this avenue, should consider the use of veteran tree management principles to initiate a reduction in canopy size to avoid major branch failures whilst stimulating a growth response that will ultimately form a new more compact canopy structure that could be managed into the future.
